CITY HALL ANNEX - FACILITY ASSESSMENT REPORT

PREPARED FOR UNIVERSITY CITY

PREPARED BY TRIVERS

2019.08.07

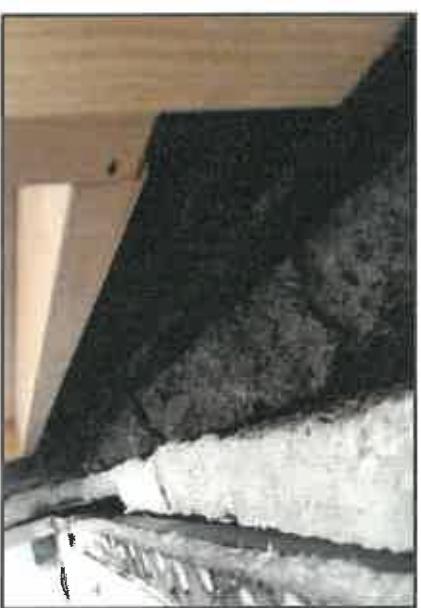
Deteriorated Lintel

Several cast in place reinforced concrete lintels along the south elevation have been compromised by water infiltration. Rust pack on reinforcing steel has spalled the lower half of the lintel.

Recommendation: Remove window and see structural assessment for further information.

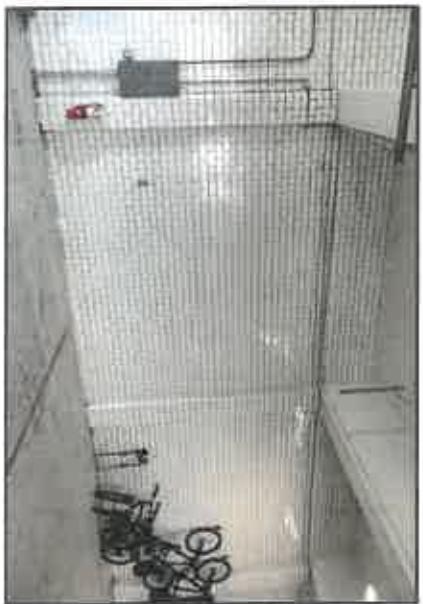
Atmospheric Staining

Glazed brick was likely added to the building when converted to the police/fire department. Brick condition is in good condition and while not original, may be beneficial to future space usage needs. Mortar is stained especially along the floor and high against the ceiling. Both are likely a result of idling emissions and/or washdown protocols.

Recommendation: Identify what extent brick may be exposed in new spaces. Remove, and re-point mortar and clean with the appropriate masonry cleaners with the gentlest means possible.

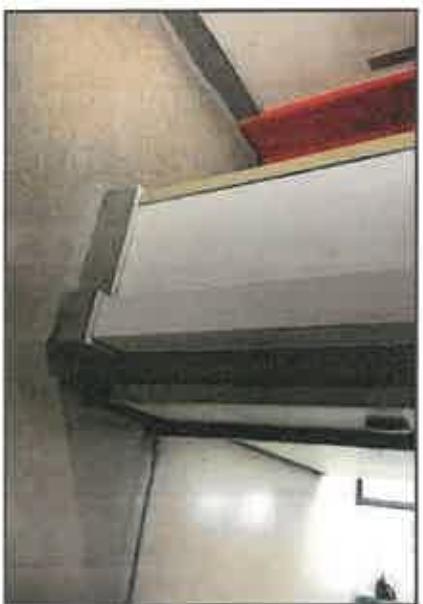
Base Trim

Stair landing rooms have base trim that are natural or synthetic plaster based stone. They are a central character defining feature and preservation shall be prioritized. In general, elements are in good albeit soiled condition. Joint sealants/mortars should be evaluated for toxic and/or toxic materials.

Recommendation: Clean with gentlest means possible to remove atmospheric and biological staining.

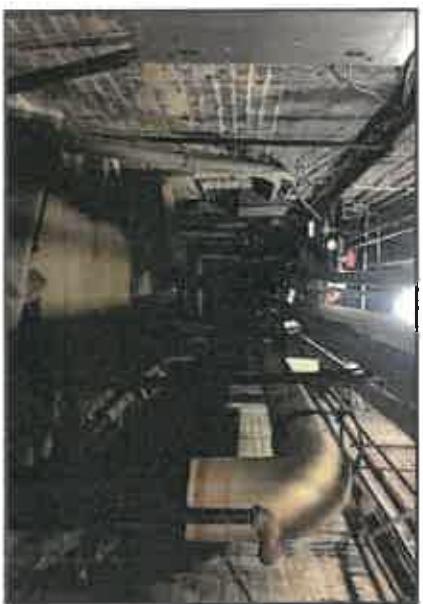
Mechanical Tunnel

A brick mechanical tunnel connects utilities between the City Hall and Annex building. The brick is lower quality and softer brick. However, it is in good condition. Toxic and hazardous material testing should be performed due to the extent of pipe wraps and coating used in the space. It is unclear if there have been water infiltration problems in this subterranean space.

Recommendation: Spot re-point as needed. Perform hazardous material testing. Apply crystalline coating if water infiltration is problematic in the space.

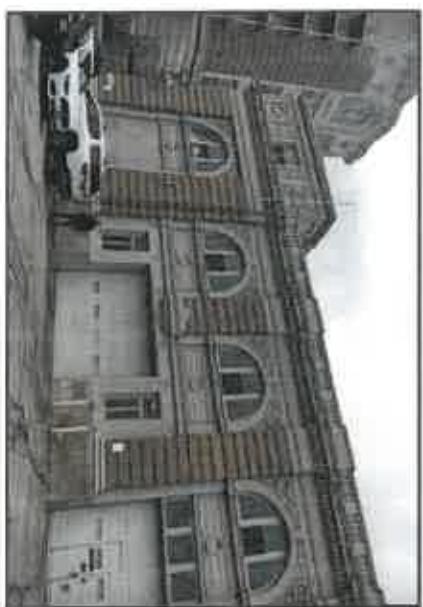
Typical Masonry Condition

Existing brick is a unique buff color in contrast to the ubiquitous red brick in the St. Louis region. Brick of this color tends to be of poorer quality and is not locally sourced. However, the masonry envelope is in good condition with proper joint material and profiling. Brick is clean and devoid of staining on all elevations. No signs of step cracking or spalling which is evidence of larger issues.

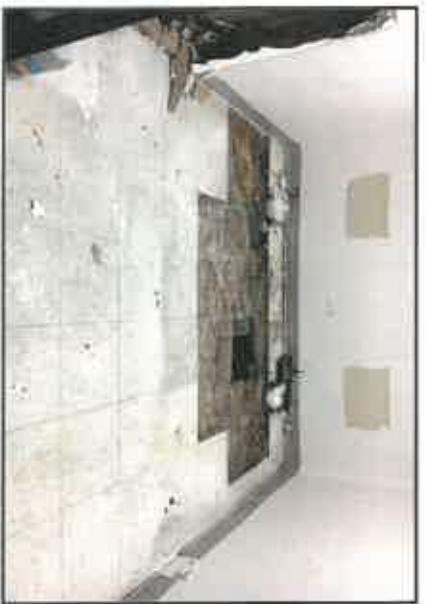
Rotted Raised Floor

Newer restrooms have been inserted at the 2nd floor. Raised flooring has been constructed which makes the restrooms inaccessible to disabled visitors/employees. In addition, plumbing fixtures had multiple leaks which resulted in significant wood rot and conditions conducive to mold growth.

Recommendation: Remove all restroom partitions and overbuilt floor materials down to historic fabric. Consider new locations and configure spaces for maximum inclusiveness.

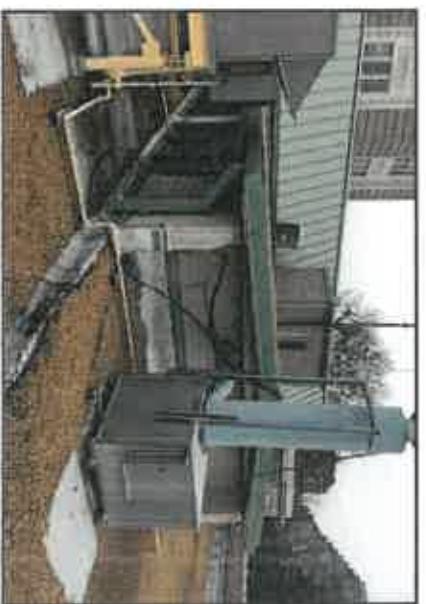
Typical/Condition

Pre-finished flashing and downspouts are in good condition. In general, most are not visible from historic elevations. Majority of gutters utilize internally draining leaders. Quantity and redundancy of drain inlets seemed to be lacking. Internal leaders were concealed in many locations and not evaluated

Recommendation: Remove and replace as needed with installation of new roof systems.

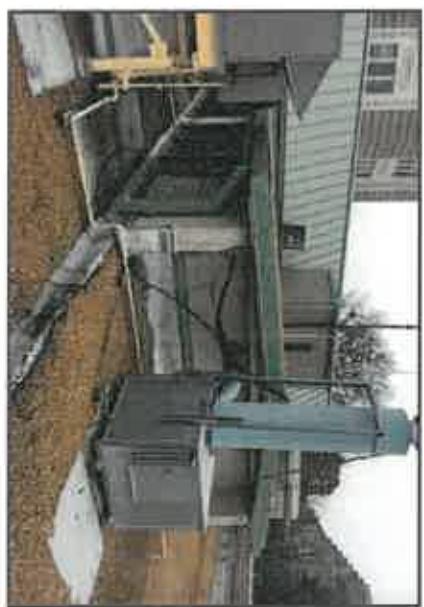
Typical Condition

Pre-finished metal flashings were in good condition, securely attached and colorfast

Recommendation: Remove and replace as required when installing new roofing systems

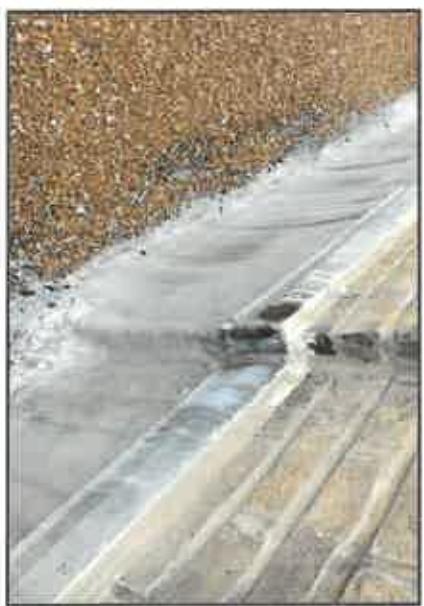
Counterflashing

Galvanized metal counter flashing was in fair condition. The flashings were serviceable but in some locations had begun rusting.

Recommendation: Remove and replace with a stainless steel counterflashing when new roofing systems are installed

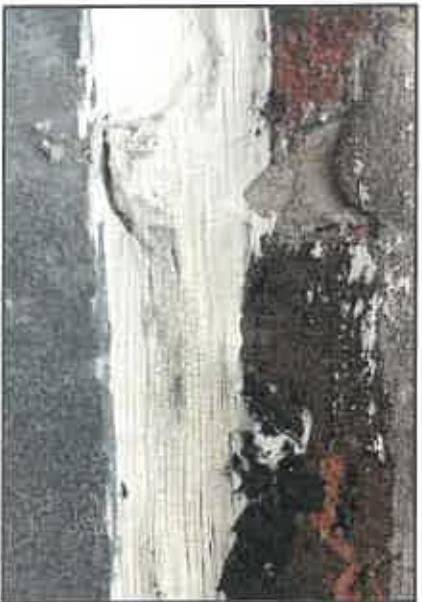
Adhesion Failure

Most joint sealants were serviceable but show signs of repeated stress and UV degradation.

Recommendation: Replace areas where sealants have failed. Evaluate sealants on a periodic basis and remove and replace accordingly.

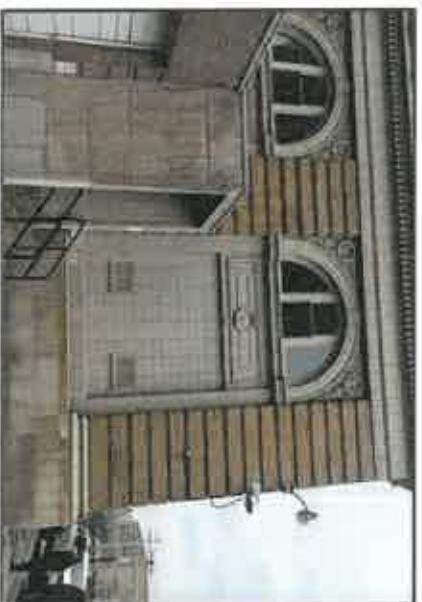
Typical Condition

It is assumed the original glazed coating of the extensive terracotta work have been compromised beyond repair. A fluid applied coating now conceals all historic terracotta. In general, the coating was in good condition and the color selection looks to be an appropriate color for the building. Additional information is needed to evaluate the longterm suitability of the coating.

Recommendation: Evaluate coatings on a periodic basis and remove and replace accordingly.

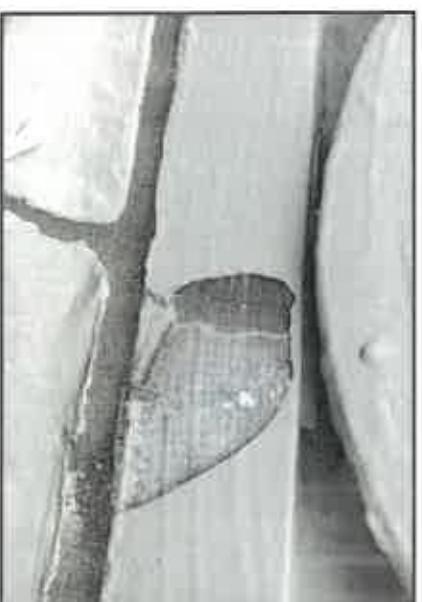
Adhesion Failure

Some locations of the terracotta coating have been compromised. This allows for possible further deteriorations as moisture is allowed into the system and the breathability of the coating is likely non-porous.

Recommendation: Remove unsound and loose materials to substrate. Reapply coating.

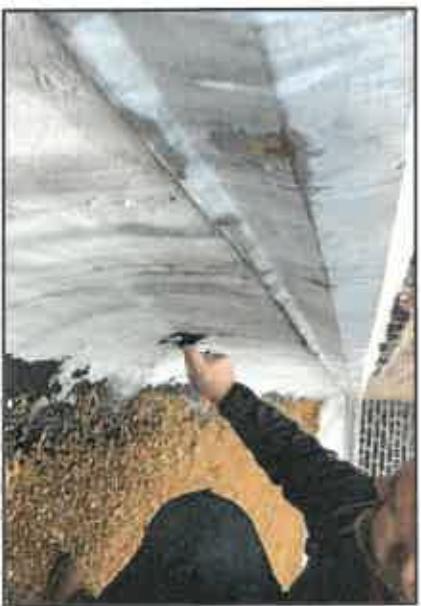
Fluid Applied Membrane Damage

A liquid aluminum coating has been applied to the EPDM roofing substrate at the vertical parapet wall surfaces. This was likely applied in an effort to add longevity or remedy observed deterioration. Several locations were found to be compromised. In some areas the liquid coating had delaminated, in others, the substrate was not suitable for liquid application.

Recommendation: None. The liquid coating is integral to the roofing membrane and will be removed as part of a new roofing system installation.

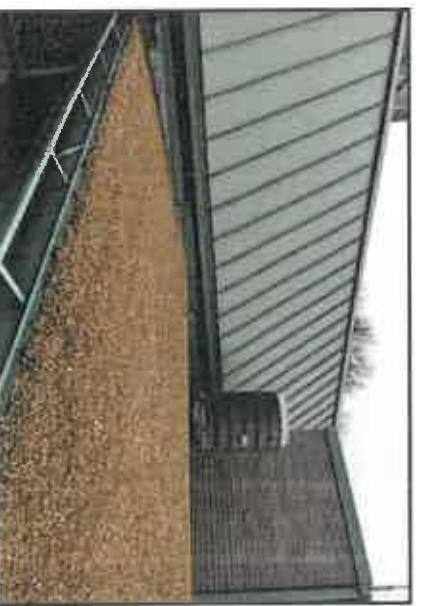
Typical Condition

Metal standing seam roofing is installed over clear-story windows. Roofing is in good condition with no obvious signs of storm damage or leaks. However, roofing obscures metal skylights that are a character defining feature.

Recommendation: Remove metal roofing and restore skylights to original conditions.

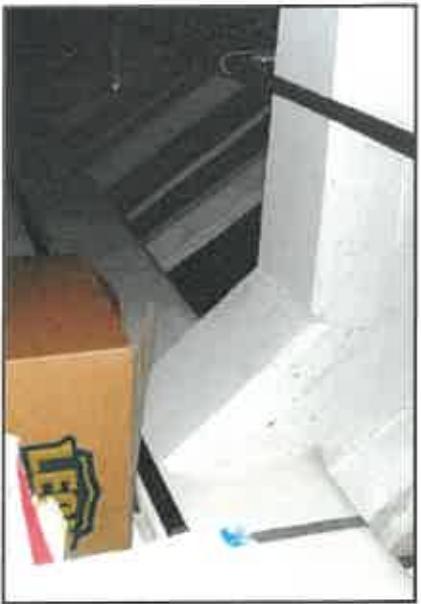
Cracking

03.03 CRACKS IN MAIN ROOF BEAMS AT MONITOR

The monitor roof construction appears to consist of a system of reinforced concrete slabs and beams. The ends of the main concrete roof beams have cracks, that could be shear cracks. We recommend that the construction type and cause of cracks be investigated to determine the cause and degree of concern.

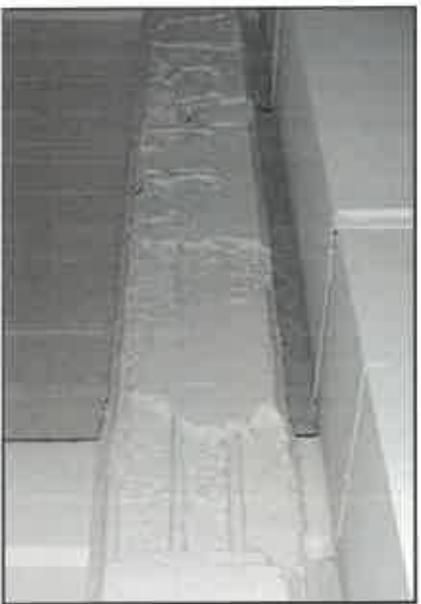
Spalling

03.03 SPALLED CONCRETE COVER AT ROOF BEAM

The roof construction consists of reinforced concrete slabs and beams. At select interior roof beams (as viewed from the second floor), the concrete cover on the bottom of the beams has spalled, exposing reinforcing steel! This lack of concrete cover does not provide an adequate fire rating for the beams.

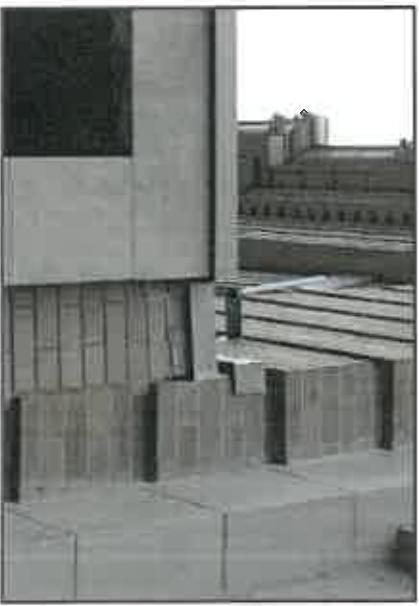
04.03 LOOSE BRICK AT GARAGE
Overload Condition

The masonry facade was re-pointed 2 to 3 years ago. In general, the masonry pointing is in very good condition, as the back side of the parapets show. The condition of the exterior masonry facade for the entire building is very good.

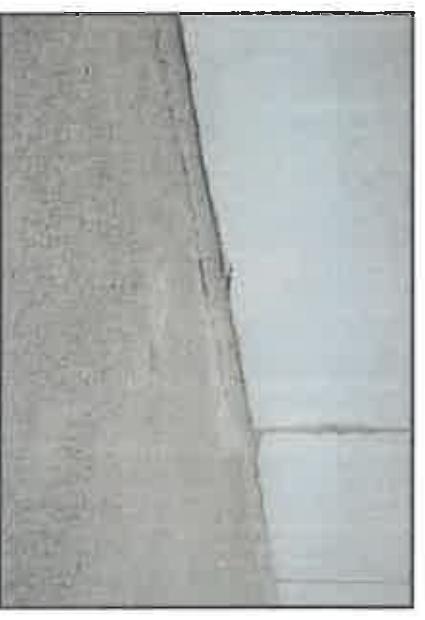
Terracotta was painted and sealed 2 to 3 years ago during the masonry restoration project. The paint is beginning to spall and peel on the water table on the east elevation. The condition shown occurs randomly around the building. The paint will continue to peel allowing moisture infiltration inside the terracotta eventually causing freeze-thaw damage.

The masonry facade was re-pointed 2 to 3 years ago during the masonry restoration project. The re-pointing mortar is starting to spall on the water table on the east elevation. The condition shown occurs randomly around the building. The mortar will continue to spall allowing moisture infiltration inside the mortar joints eventually causing freeze-thaw damage.

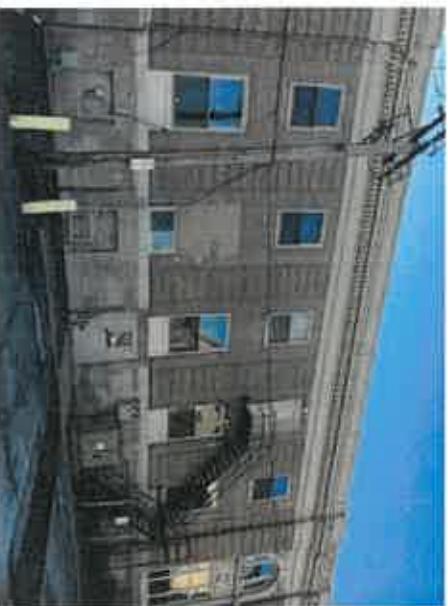
There is no caulking above the garage door lintel on the east elevation. Water can accumulate in the gap between the masonry and steel lintel, eventually causing rust and deterioration to the steel lintel.
