CITY HALL ANNEX - FACILITY ASSESSMENT REPORT

PREPARED FOR UNIVERSITY CITY

PREPARED BY TRIVERS

2019.08.07

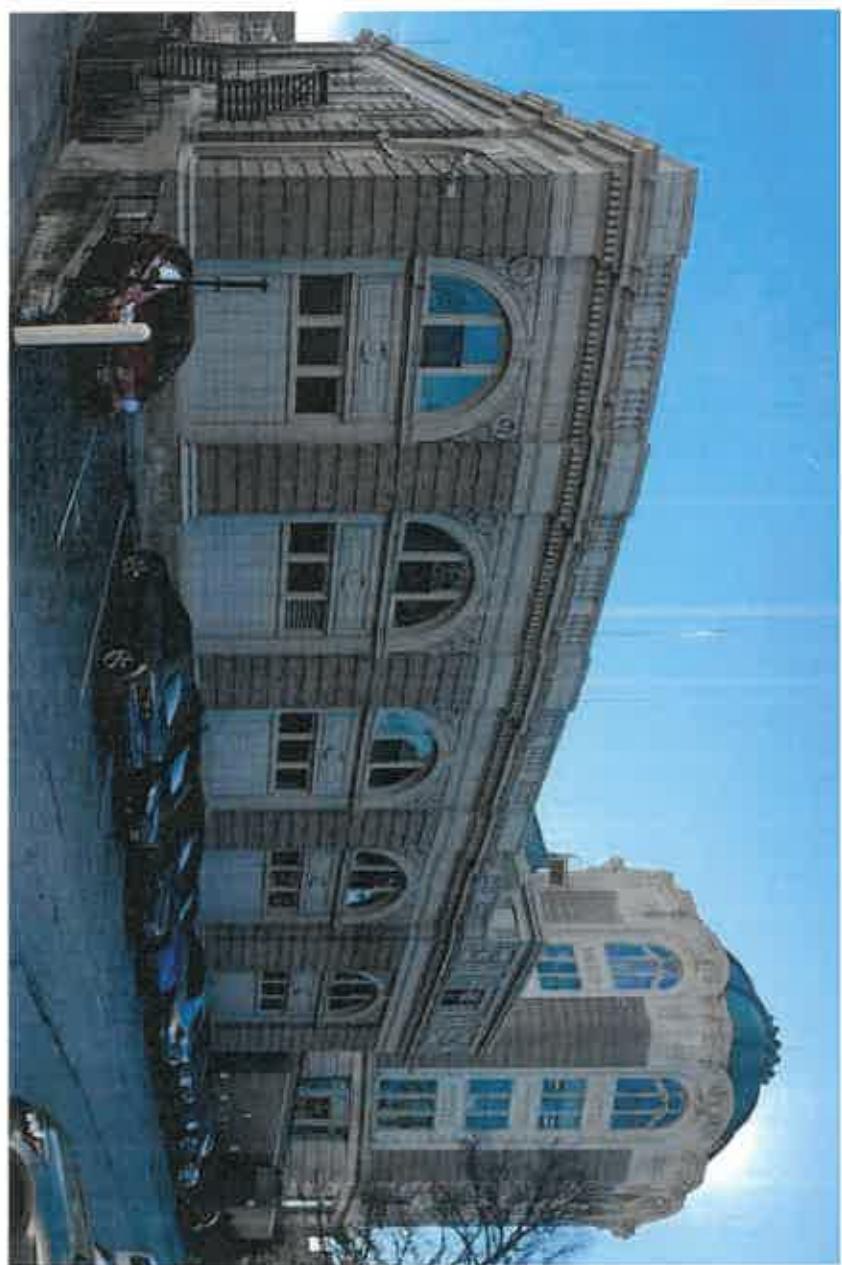
Structurally, the building has several shortcomings in context of the building's test-fit program. The lateral bracing system could require significant seismic retrofit but extent of work is to be determined as required by code interpretation and final use determination. Several other minor issues include deteriorated cast in place concrete window lintels and limited spalled concrete at load bearing beams. Required program area may necessitate removal of the structural system installed specifically for the fire engine bays.

Removal would afford an increase in net area in the basement.

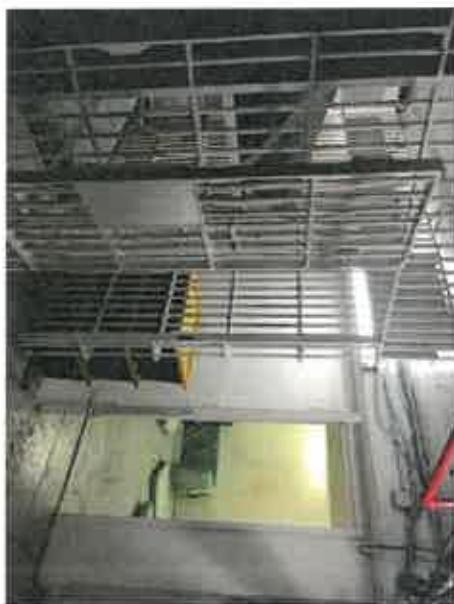
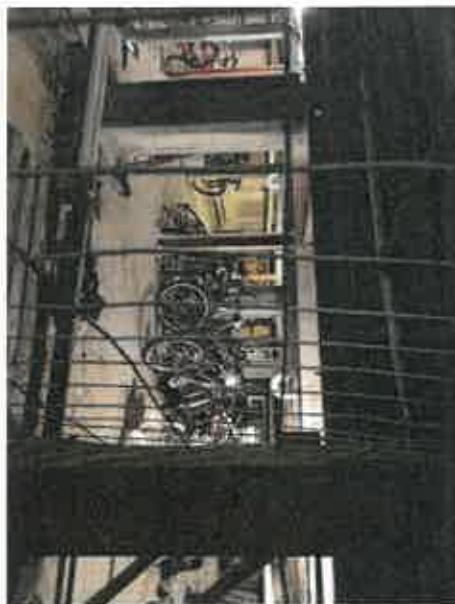
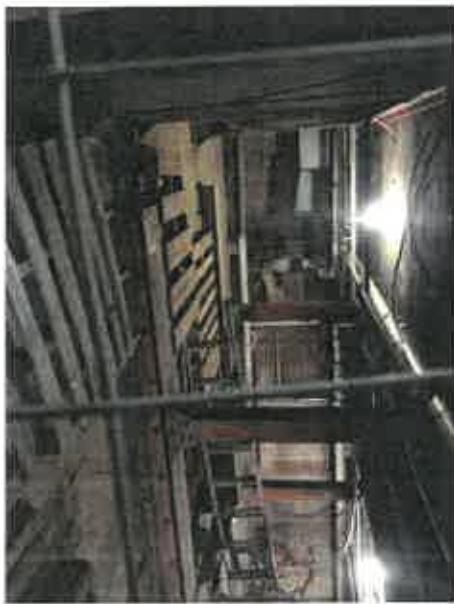
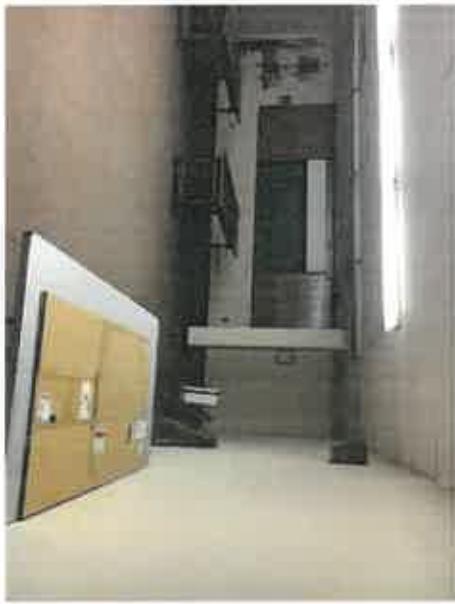
Approximately 4,000 square feet of the building are currently used for stolen bicycle storage. The lowered head clearance is resultant of the lowered floor elevation above as required for fire engine access at the first floor. Removing this modification would greatly increase the program flexibility in the basement. In addition, several window openings have been infilled which could be reopened to further improve the conditions within the space.

The inmate cells are unsafe as they have only one means of egress and do not have access to daylight. Relocation of these spaces should be considered.

The "EOC" has been described as a bunker like environment. In terms of safety, this is advantageous but is not a desirable work environment. This space should be relocated, potentially offsite, which may help decentralize some critical services and afford better working environs.

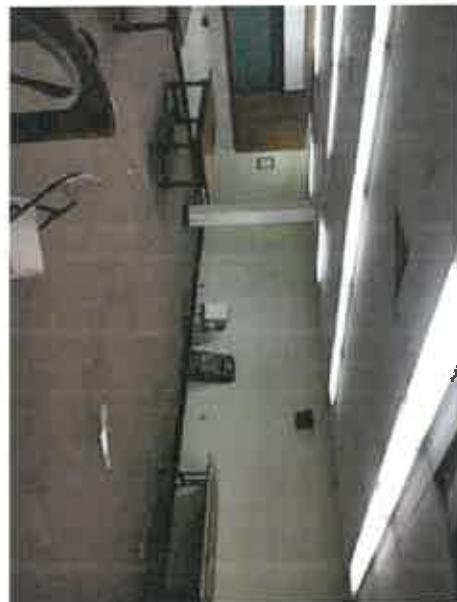
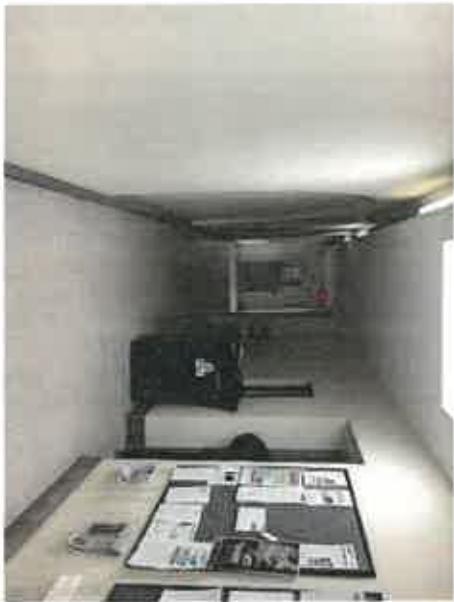
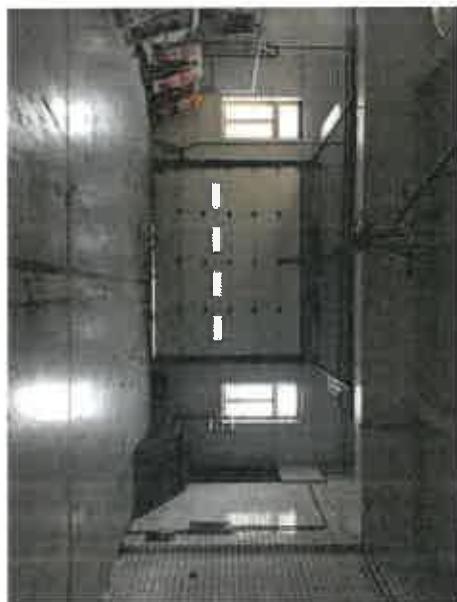
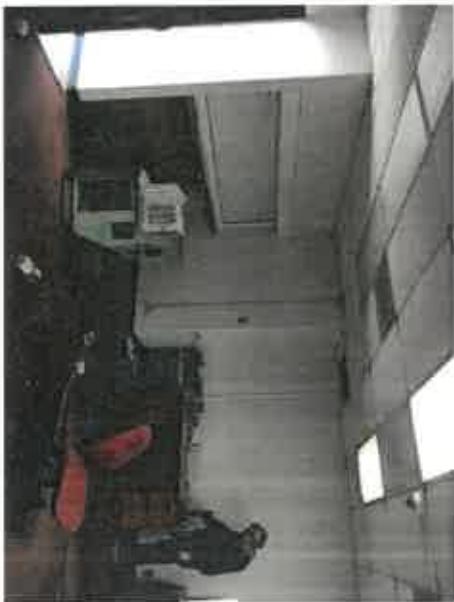
FIRST FLOOR

The eastern side of the building is primarily office space. The area has few to no limitations on space configurations and has generous ceiling heights.

The western side of the building has been significantly altered to accommodate the fire department once housed within the building. The floor has been lowered several feet in all but the southernmost bay. The area is currently completely inaccessible for those with disabilities. The elevator does not service this half level and two stairs connect this level to the primary first floor level. The window openings on this elevation have been altered significantly by removing the sills and widening at least one bay. The result is several different window and door openings that are not consistent with the historical rhythm of the building.

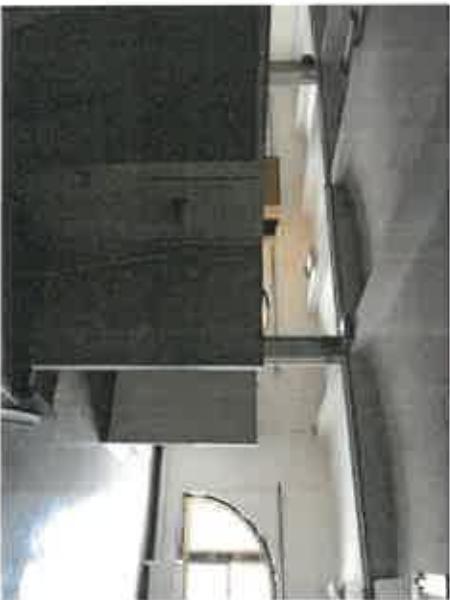
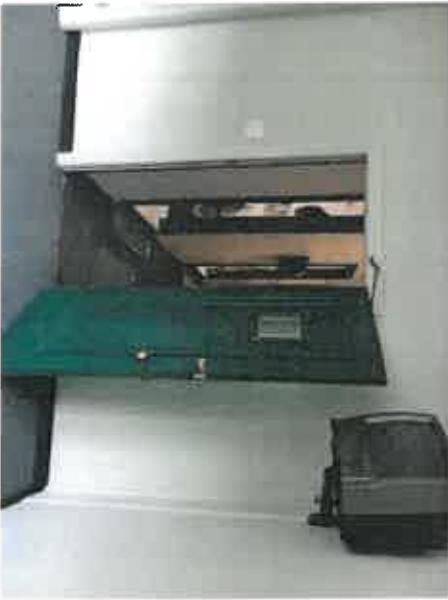
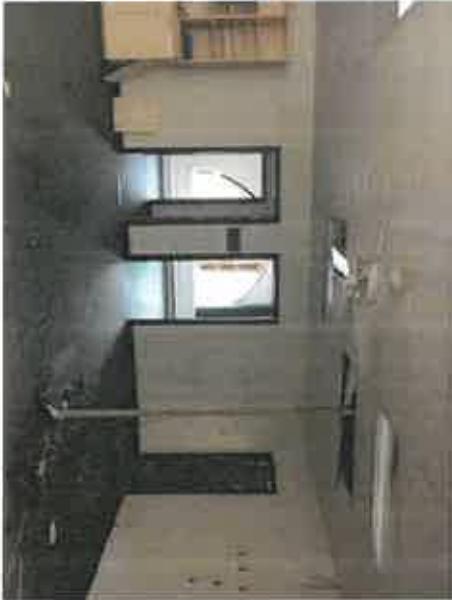
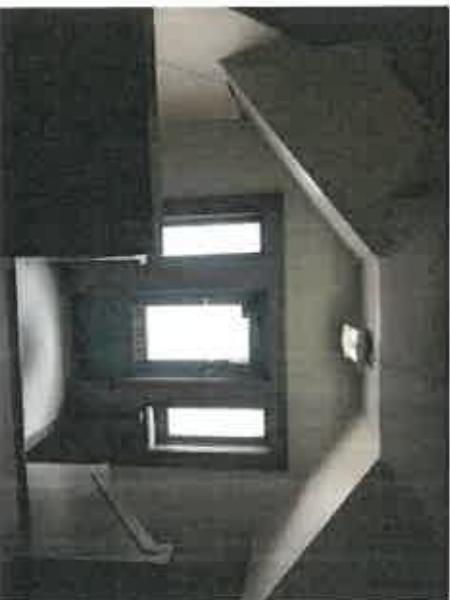
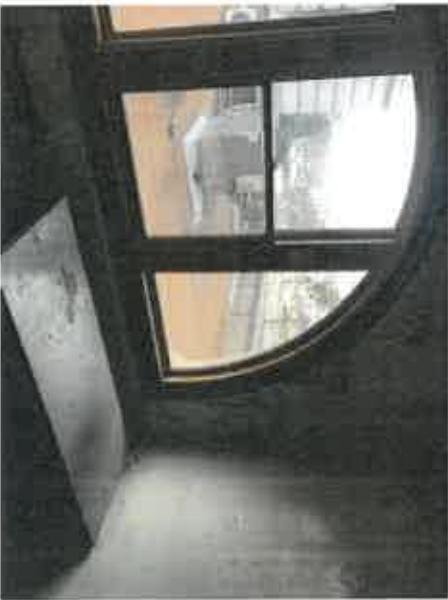
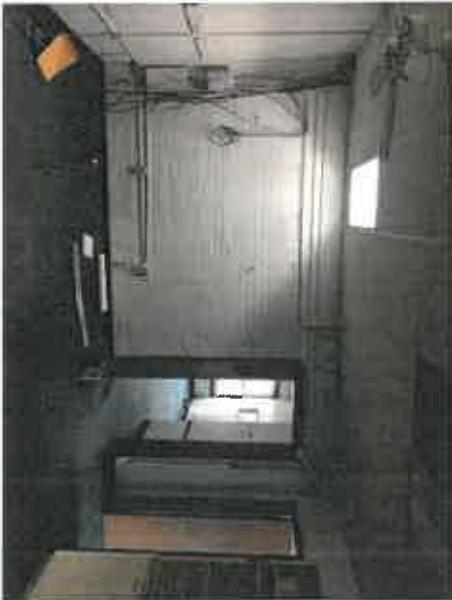
SECOND FLOOR

The ceilings are exposed board formed concrete barrel vaults. Similar to the windows, these elements can organize new space configuration. The floors may have original wood, but the extent of flooring is unknown due to the multiple layers of flooring.

Originally this level was a open floor plate with large amounts of daylight. New spaces should be organized to allow the occupant to recognize the historic volume and maintain historic elements.

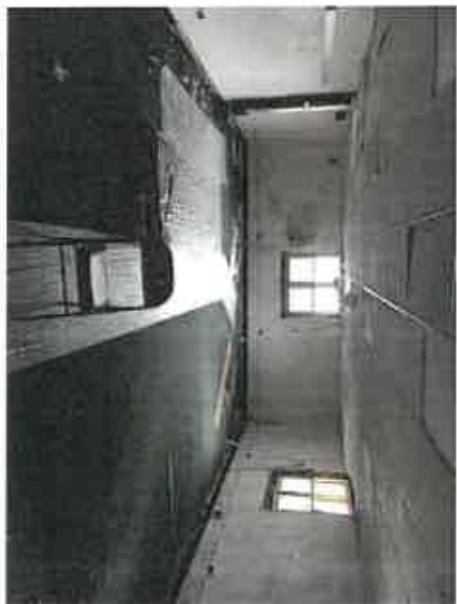
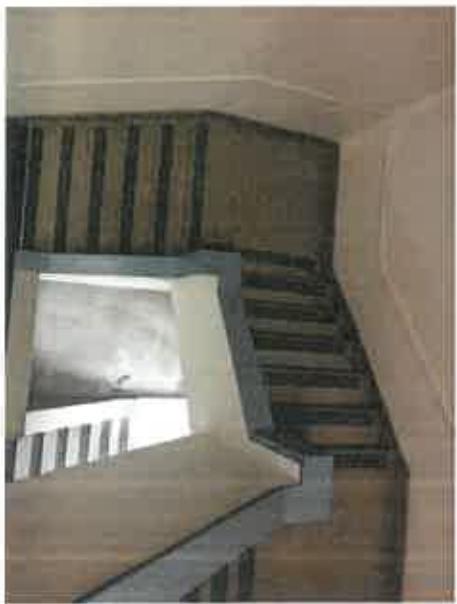
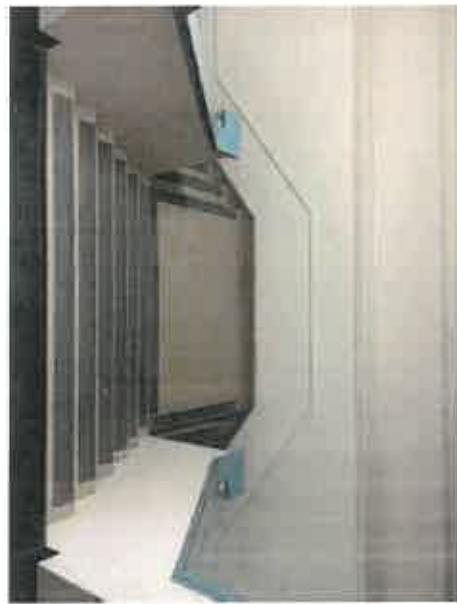
THIRD FLOOR

The third floor is smaller in area than the other three floors. It is one bay in width along the entire south end of the building. The stair hall bisects the floor plate which creates two equally sized rooms. Ceiling heights are much shorter on this floor. However, a set of north-facing unitized skylights add ceiling height and potential to flood the stair hall with natural light. Currently the skylights have been roofed over but look to be suitable to renovate and reuse. The windows are significantly smaller at this floor. Wood flooring was found under the existing carpeting and could potentially be salvaged and refinished.

There is access to the rooftop which could be investigated for an addition if space is needed. However, the addition should be offset from the building facade as to not negatively impact the historic sightlines of the existing building.

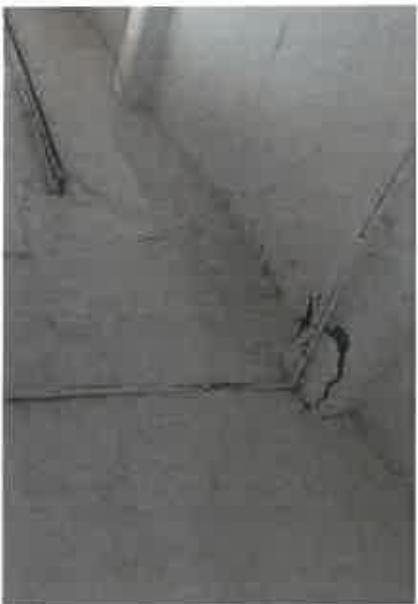
03.00 CONCRETE
Spalled Beam

At the 2nd floor south wall there is one instance of a spalled concrete beam at its intersection with the exterior wall. This represents concern both architecturally and structurally. See structural assessment for additional information

Recommendation: Remove loose and unsound material. Document condition of reinforcing steel. See structural assessment for additional information.

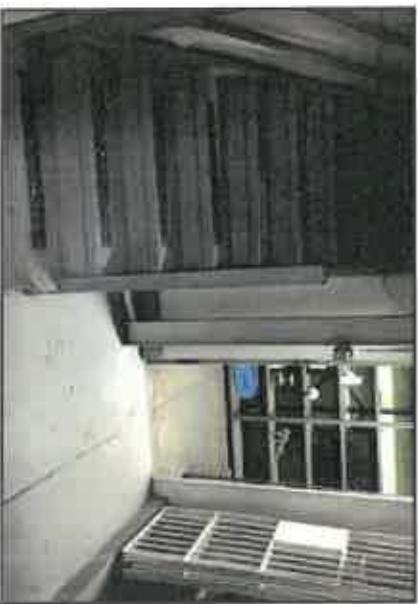
03.00 CONCRETE
Exposed Slab on Grade

Exposed concrete slabs are mainly confined to the basement and hi-bay areas. In general, slabs were found to be in good condition with adequate crack control joints. Concrete coatings and finishes ranged from none to painted

Recommendation: Evaluate moisture content of concrete at basement level for suitability of adhesives and floor finishes. Remove loose and unsound finishes and clean and prepare surface for new floor finishes.

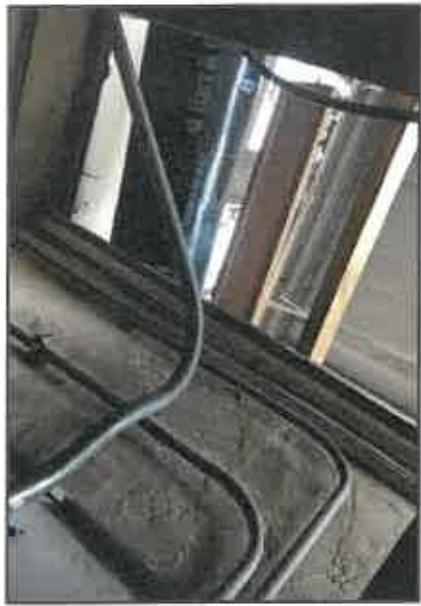
03.00 CONCRETE

A concrete penthouse compromised of concrete columns, beams, and board formed roof deck is located at the central column bay running east-west for several bays. It is concealed above dropped ceilings in secured evidence storage rooms. Several additional bays have been infilled to eliminate the penthouse. The concrete structure looks to be appropriately roofed and painted with only minor indications of deterioration.

Recommendation: Limit use of dropped ceilings and organize systems to coordinate with penthouse. Consider restoring extents of penthouse for entire length of building. Emphasize the penthouse as a character defining feature and organizing element. See structural assessment for additional information.

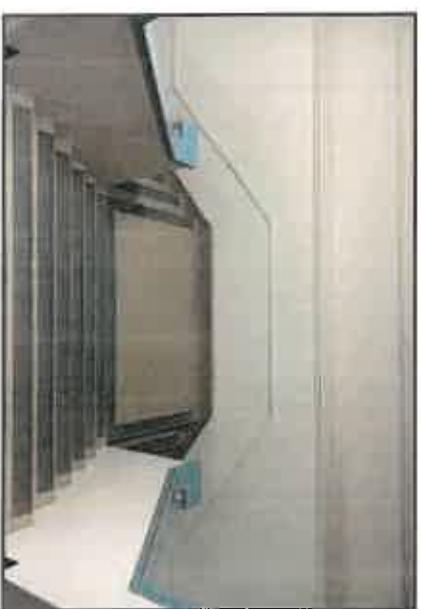
03.00 CONCRETE

It is assumed existing stair treads and risers are cast-in-place concrete however they could be terrazzo. The painted surfaces are not adequately slip-resistant and are high-maintenance. Stair tread rise and run are not compliant with current codes.

Recommendation: Clean and prep for new floor finishes. Modify existing guardrails to meet code required height and add handrails. Consider new stair for primary vertical circulation and limit public use to the extent possible.

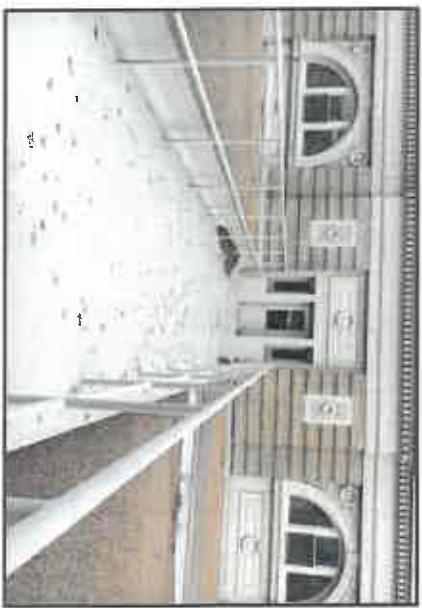
Rooftop walk looks to be in good condition. No cracking or other signs of roof deflection. Walking surface coating is sanded but should be evaluated to ensure proper slip coefficient. Walking surface is not adequately lit.

Recommendation: Maintain surface coating and test for proper slip coefficient. Provide Min 3 footcandles per foot at walking surface.

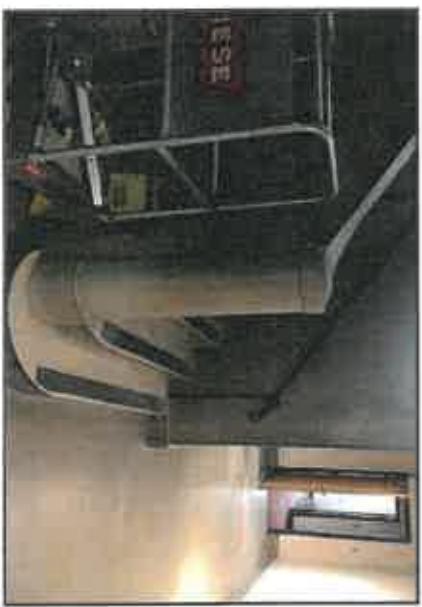
Stone Railings/Wainscoting

Existing stair elements including the railings, newelpost, wainscoting, base, treads, and risers are natural or synthetic plaster based stone. They are a central character defining feature and preservation shall be prioritized. In general, elements are in good albeit soiled condition. Joint sealants/mortars should be evaluated for toxic and/or toxic materials.

Recommendation: Clean with gentlest means possible to remove atmospheric and biological staining.

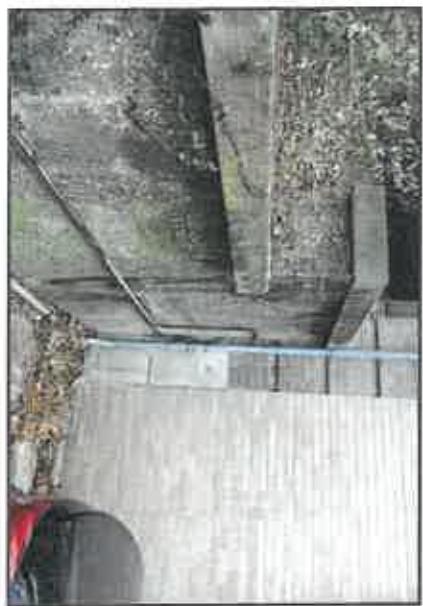
Site Walls

Site retaining walls concrete with extensive biological and atmospheric staining. The walls are unsightly and located adjacent to Annex Building entrances.

Recommendation: Apply biological and atmospheric cleaners.

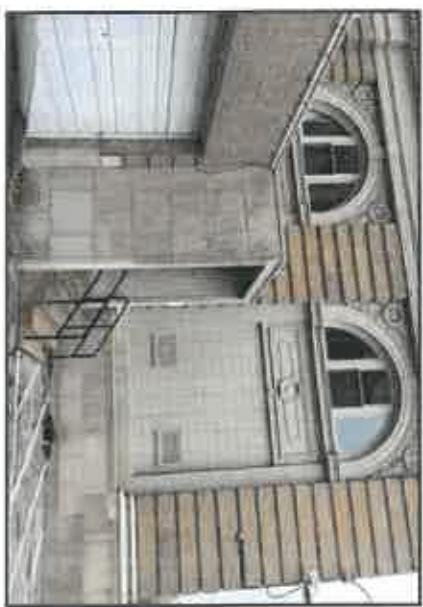
Inappropriate Material

Glazed concrete masonry units in stack bond, infill existing opening once occupied by windows. The material, scale and pattern are not consistent with the larger building

Recommendation: Remove infill materials and replace with windows. Consider new space uses that may utilize additional natural light.

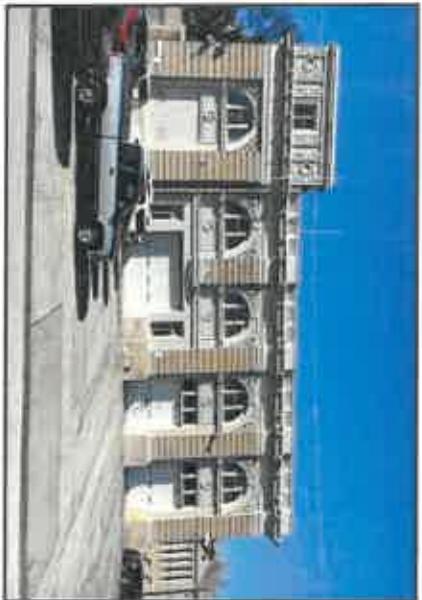
Modified Openings

All five bays at ground level have been modified in height and or width to accommodate emergency vehicle access. Bays 2 and 3 have been modified to create a single opening that reads as historic but is in fact arbitrary and not historically accurate.

Recommendation: Evaluate future space needs to determine if openings are still needed in the current configuration. If needed, consider more appropriate overhead doors. If not needed, restore openings to original configurations as allowable by program needs.

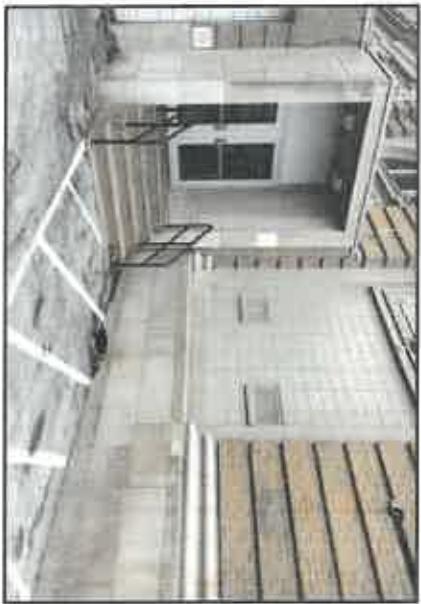
Historically Inaccurate

Exterior metal doors, frames, And blind transoms are in good condition. However, anodized aluminum finish is not historically compatible.

Recommendation: Remove and replace with door styles and colors that are more consistent with the color and style of the building.

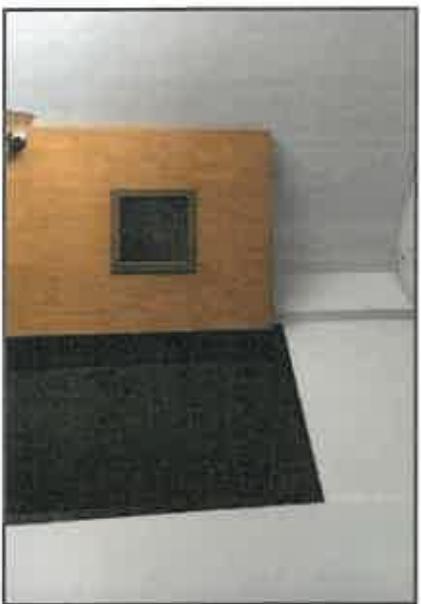
Typical Condition

Interior hollow metal frames are functional but utilitarian. Door leaves were inconsistent in both material, style, and finish.

Recommendation: Consider consistent door types and frame types. Reserve current frame and door styles for back of house and/or strictly utilitarian functions.

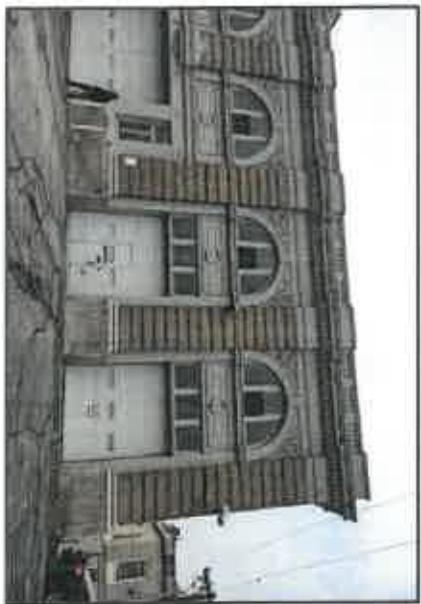
Historically Inaccurate

Overhead doors are inconsistent with the period of significance. Doors should be considered for removal.

Recommendation: Restore openings to original configuration if possible. Where overhead doors are required, provide insulated, energy efficient options with details more compatible with historic building.

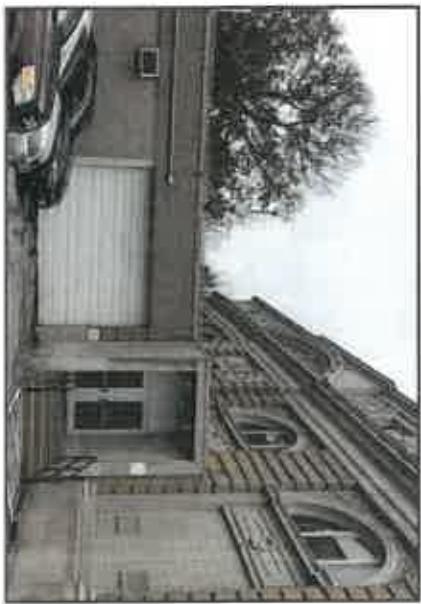
Historically Inaccurate

Proximity of door to entrance is undesirable and confuses wayfinding. This overhead door in particular should be removed or the entrance location should be reconsidered.

Recommendation: Infill openings where overhead doors are no longer needed. Consider storefront systems that adequately differentiate themselves from historic elements. Where overhead doors are required, provide insulated, energy efficient options with details more consistent with historic building.

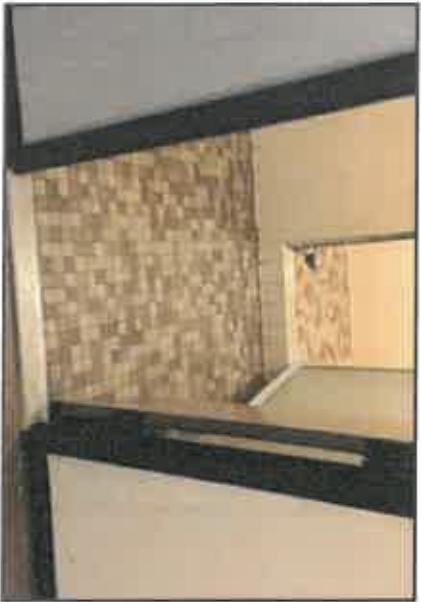
Restroom Conditions

Mosaic, small format tile was present on floors and 4" square tile was present on the walls of the restrooms. They are functional but have a high proportion of grout joints to solid surface which results in high maintenance requirements and fosters unsanitary restroom environments.

Recommendation: Consider large format tile in colors that demonstrate sanitary conditions.

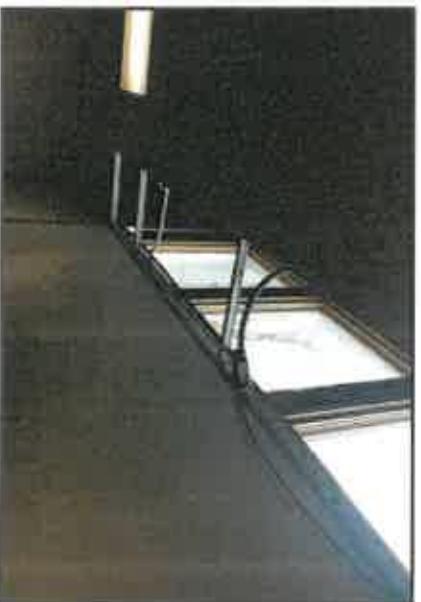
Dropped Ceilings

Dropped ceilings significantly altered the quality of the spaces especially at the first floor. Most transom level windows were completely concealed above the ceiling plane.

Recommendation: Remove acoustical ceiling tile systems. Consider floating planes and/or ceiling soffits that allow spaces to have access to natural light to the greatest extent possible.

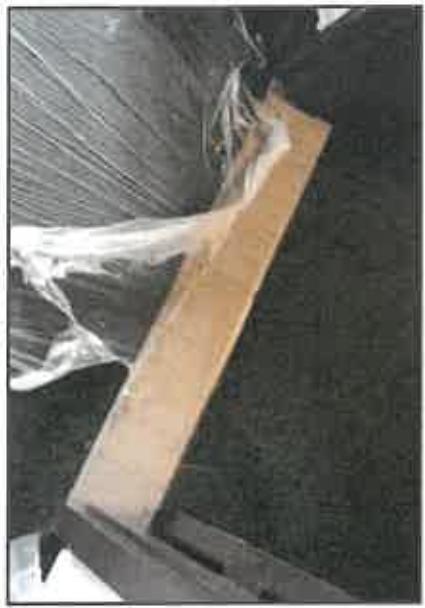
09.05 STONE FLOORING

Stone flooring at the stair landings are in good condition. Some minor staining and loss of finish are evident

Recommendation: Remove stains using the gentlest means necessary and grind as needed to remove deeper scratches and gouges.

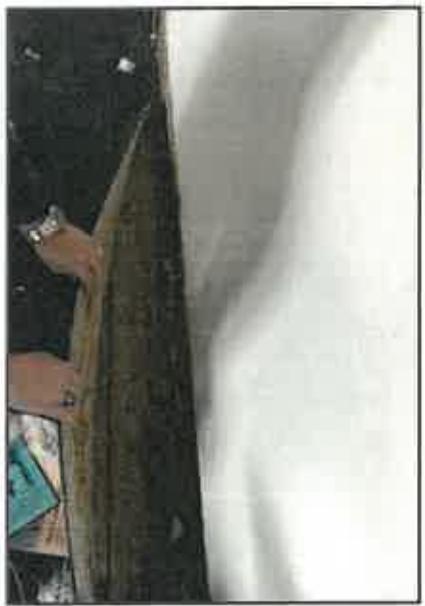
09.06 WOOD FLOORING

Stone thresholds were found in few locations. They are historic and should be preserved in any new flooring application

Recommendation: Maintain in place.

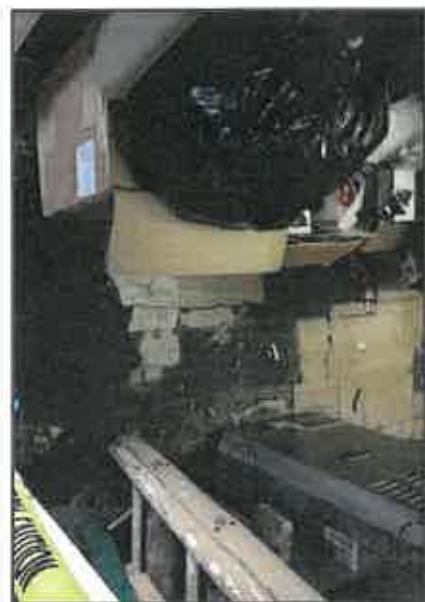
09.08 RESILIENT FLOORING

Original wood flooring was found in multiple locations below vct and carpet. Original flooring materials are important contributors to the quality of historic spaces.

Recommendation: Remove flooring materials concealing wood floors. Evaluate condition of wood flooring and identify areas where wood could be exposed in new spaces.

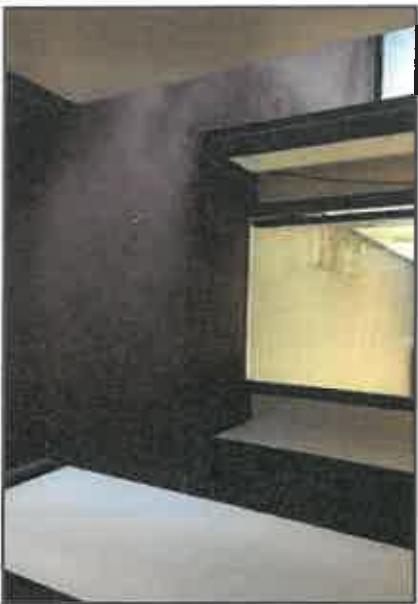
09.11 SHEET CARPETING

Stained/Crushed Pile

Existing carpets are beyond their useful life. Wide-spread staining and crushed pile were observed in most spaces.

Recommendation: Remove all carpeting. Consider carpet tiles and/or more durable flooring materials that require less maintenance, have more longevity, and could be replaced in part as needed when damaged beyond repair.

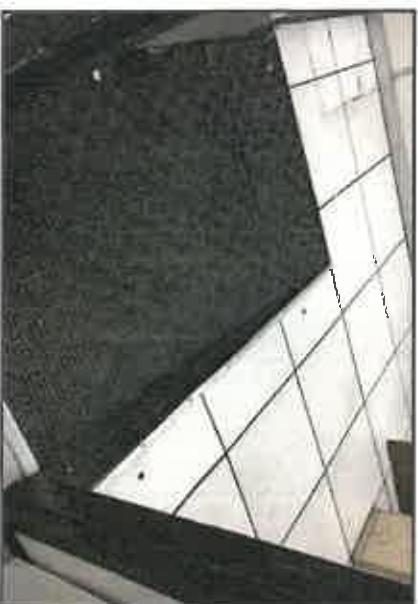
09.14 RAISED FLOOR

General Condition

Recommendation: Remove flooring system.

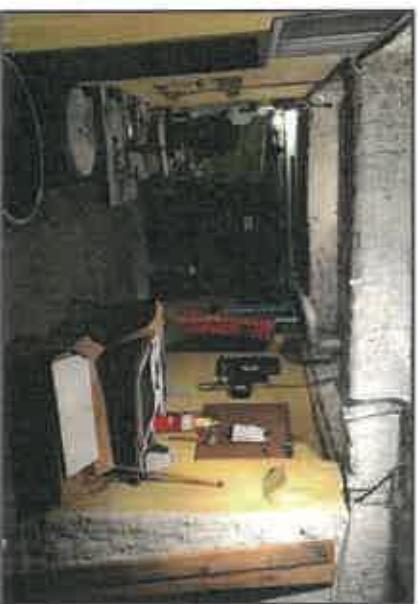
09.15 ACOUSTIC COATING

General Condition

Acoustic coatings are present on many wall and ceiling surfaces. This sound mitigation material is antiquated and the firing range is not currently master planned for the same location. Lastly, the material is porous which presents two additional concerns in that cleanliness cannot be maintained and lead dust is captured which is a significant health risk. See environmental reports for additional hazardous material information.

Recommendation: Remove all acoustic coating in keeping with hazardous material removal protocol.

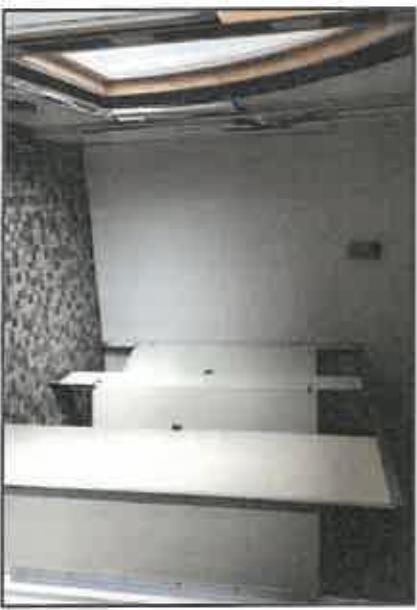
10.04 TOILET COMPARTMENTS

Non-ADA compliant

Current toilet compartments are in fair condition. New restroom layouts will not match existing in size or layout. In addition, current compartments are floor mounted and make housekeeping difficult and have shorter lifespan due to contact with wet surfaces.

Recommendation: Dispose of toilet compartments.

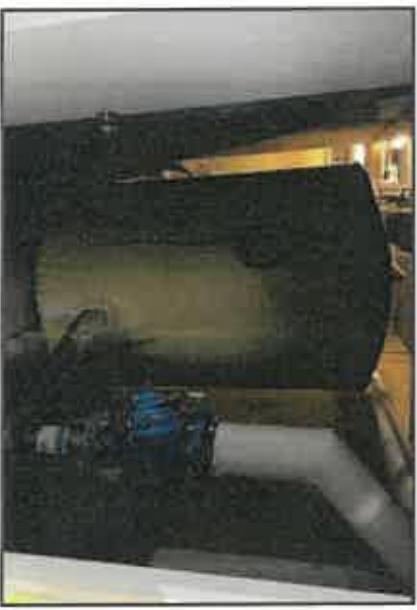
11.01 Water Reservoir

General Condition

A single hot water source is inefficient and not needed in future uses. See environmental report for any additional hazardous material information associated with tank piping or room finishes.

Recommendation: Remove tank and consider point source hot water for future needs.

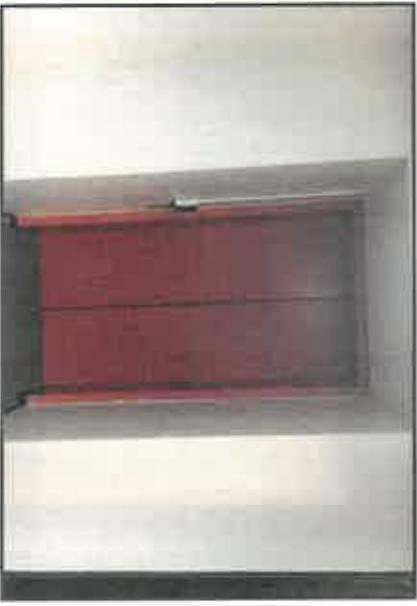
14.01 ELEVATOR

General Condition

Recommendation: Review future circulation paths and consider all users when establishing best location for vertical circulation. Consider locations which minimize impact to historic building materials as designated in attached preservation plans.

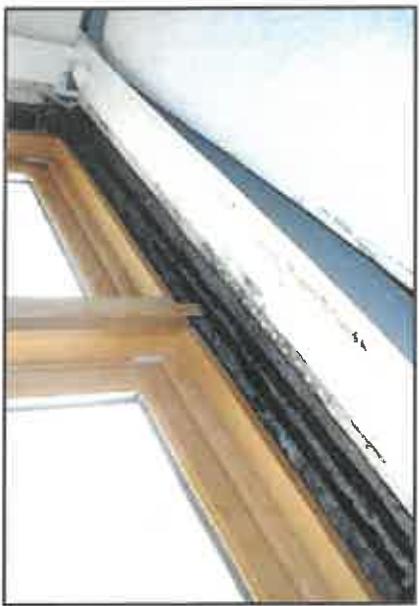
03.03 RUSTED REBAR AT WINDOW LINTELS

Natural Seams

Lintels consist of reinforced concrete. Moisture damage has saturated the concrete in the past and has caused the reinforcing steel to rust and expand, resulting in spalled concrete. Exposed conditions exist on the third-floor south elevation on the west side. Other latent but not visible conditions could exist at other locations with flat window heads.

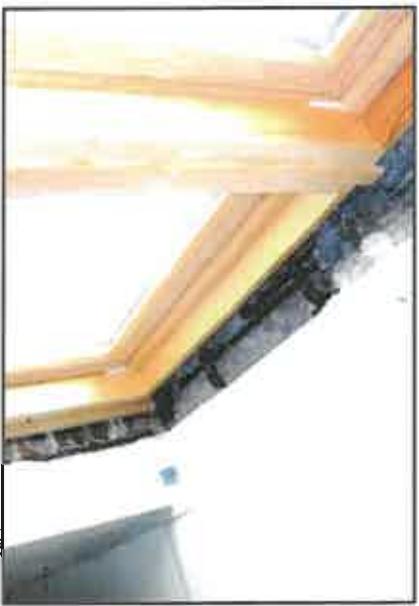
03.03 RUSTED REBAR AT WINDOW LINTELS

Freeze-Thaw Damage

Lintels consist of reinforced concrete. Moisture damage has saturated the concrete in the past and has caused the reinforcing steel to rust and expand, resulting in spalled concrete. Exposed conditions exist on the third-floor south elevation on the west side. Other latent but not visible conditions could exist at other locations with flat window heads.

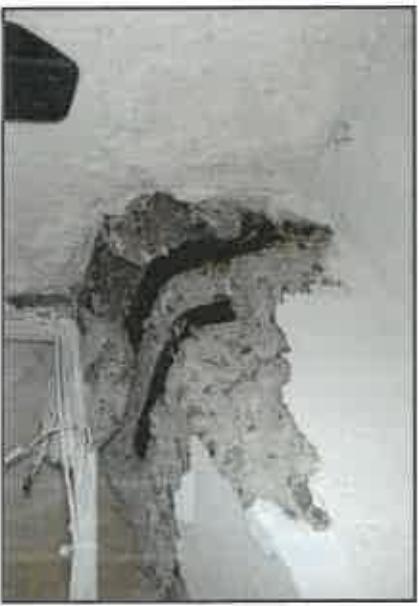
03.03 SPALLED CONCRETE AT ROOF BEAM

Overload Condition

The roof construction consists of reinforced concrete slabs and beams. Moisture damage has saturated the concrete beams at beam pockets in the past and has caused the reinforcing steel to rust and expand, resulting in spalled concrete. Exposed conditions exist on the roof east elevation towards the center of the building as viewed from the second floor at two locations.

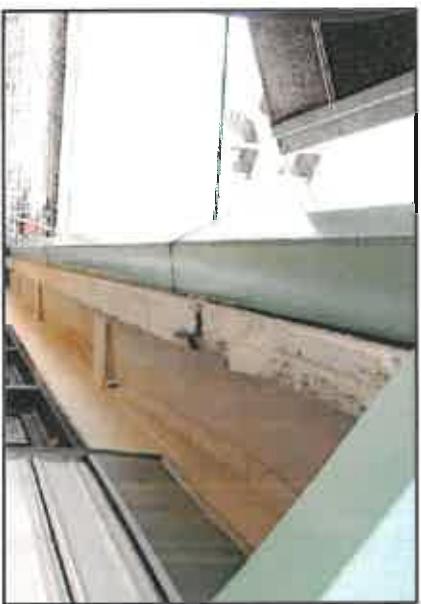
03.03 SPALLED CONCRETE COVER AT MONITOR ROOF

Spalling

The monitor roof construction consists of reinforced concrete. Concrete has spalled at the gutter line exposing the reinforcing steel bars to the elements. Long term exposure will cause deterioration to the reinforcing steel.

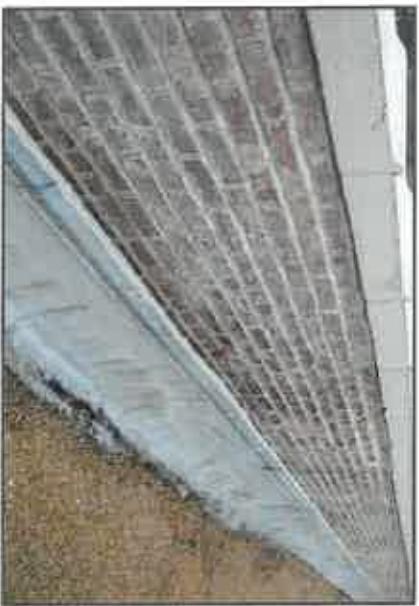
04.03 POINTING AT PARAPET

The masonry facade was re-pointed 2 to 3 years ago. In general, the masonry pointing is in very good condition, as the back side of the parapets show. The condition of the exterior masonry facade for the entire building is very good.

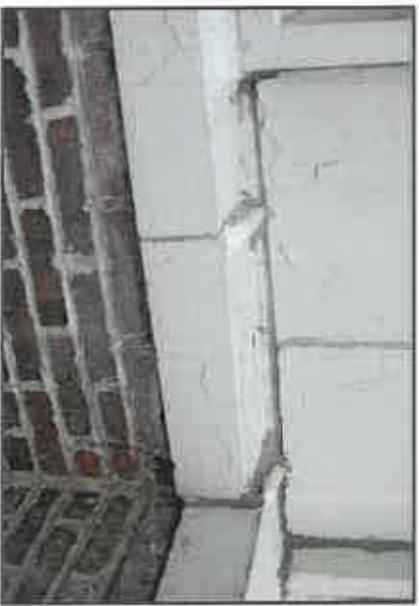
04.03 POINTING AT THIRD FLOOR CORNICE

The masonry facade was re-pointed 2 to 3 years ago. In general, the masonry pointing is in very good condition, as the north side of the third-floor cornice shows. The terracotta on the building appears to have also been painted and sealed. The condition of the exterior masonry facade for the entire building is very good.

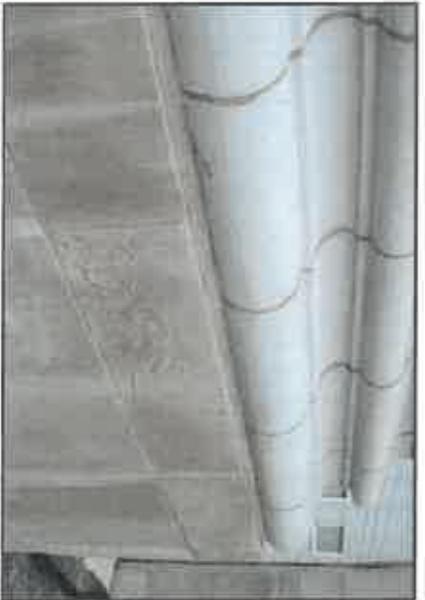
04.03 SPALLING RE-POINTING MORTAR

Spalling

The masonry facade was re-pointed 2 to 3 years ago during the masonry restoration project. The re-pointing mortar is starting to spall on the water table on the east elevation. The condition shown occurs randomly around the building. The mortar will continue to spall allowing moisture infiltration inside the mortar joints eventually causing freeze-thaw damage.

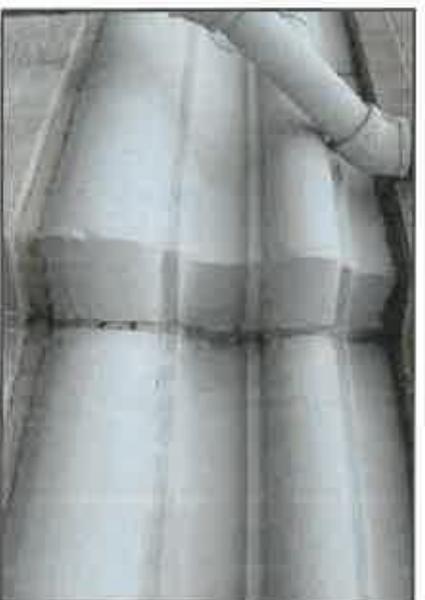
04.03 CRACKED RE-POINTING MORTAR & SPALLING PAINT AT TERRACOTTA

Spalling

The masonry facade was re-pointed and terracotta painted and sealed 2 to 3 years ago during the masonry restoration project. The re-pointing mortar is starting to crack and paint starting to peel at localized locations on the water table on the east elevation. The condition shown occurs randomly around the building. The cracked mortar and peeling paint will continue to crack, spall and peel allowing moisture infiltration inside the mortar joints and into the terracotta eventually causing freeze-thaw damage.

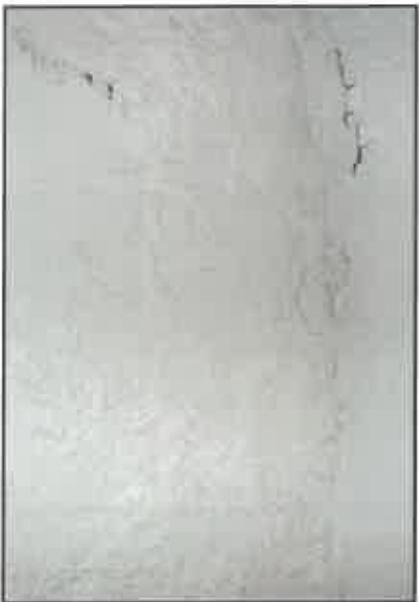
04.03 BUBBLED PAINT FROM MOISTURE INFILTRATION

Paint has "bubbled" randomly throughout the building on the inside of exterior walls. The masonry facade was re-pointed and terracotta painted and sealed 2 to 3 years ago during the masonry restoration project. Thus, the bubbled paint could be a result of moisture infiltration into the masonry wall prior to the facade restoration and may not be advancing. We would suggest removing the interior paint in bubbled areas to allow the moisture in the masonry to evaporate, then re-paint. Refer to environmental engineer assessment for hazardous material content discussion.

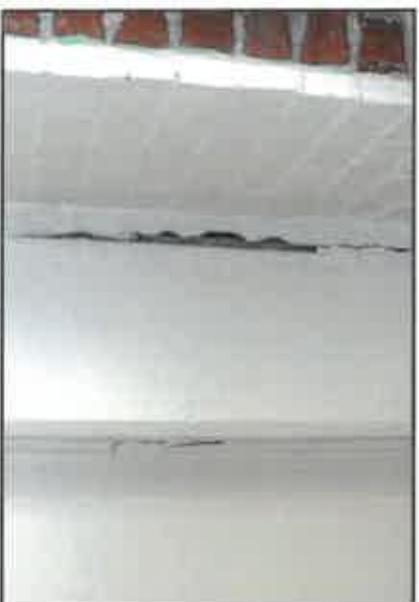
04.20 NORTH WALL SEPARATION AT COLUMN

The north exterior masonry wall was added to the structure when the northern portion of the building was demolished from fire damage. The wall sits outside the concrete frame at this elevation. The wall has separated from the concrete frame at certain locations, primarily on the middle of the elevation. This is likely from expansion/contraction from temperature changes and possibly moisture infiltration. It is not known whether the masonry facade was anchored to the concrete frame when constructed. We suggest that an investigation be performed on any facade anchorage, and the wall be anchored to the concrete frame if it does not exist, or if it is found to be inadequate.

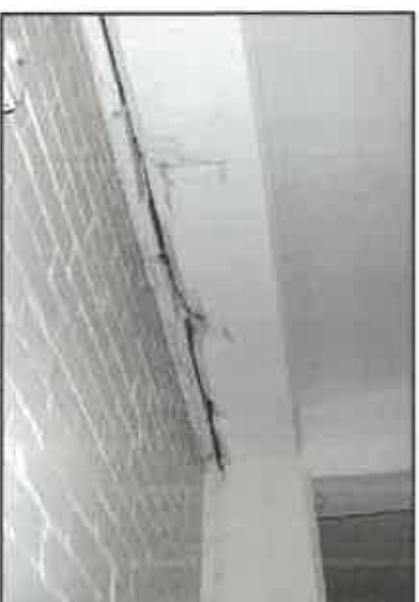
04.20 NORTH WALL GAP AT FLOOR BEAM

The north exterior masonry wall was added to the structure when the northern portion of the building was demolished from fire damage. The wall sits outside the concrete frame at this elevation. The wall has separated from the concrete frame at certain locations, primarily on the middle of the elevation. This is likely from expansion/contraction from temperature changes and possibly moisture infiltration. It is not known whether the masonry facade was anchored to the concrete frame when constructed. We suggest that an investigation be performed on any facade anchorage, and the wall be anchored to the concrete frame if it does not exist, or if it is found to be inadequate.

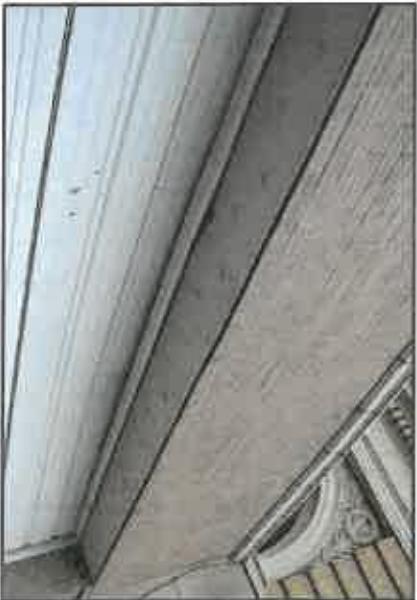
05.52 STEEL FIRE ESCAPE RAILING

The railing at the steel fire escape on the north elevation does not appear to meet building code requirements. Other structural members such as plate stringers and posts appear to be undersized based on current code requirements. Also, the egress route is not covered. We suggest that an architectural and structural review be undertaken to determine the adequacy if the fire escape, and that it be upgraded or replaced as required.

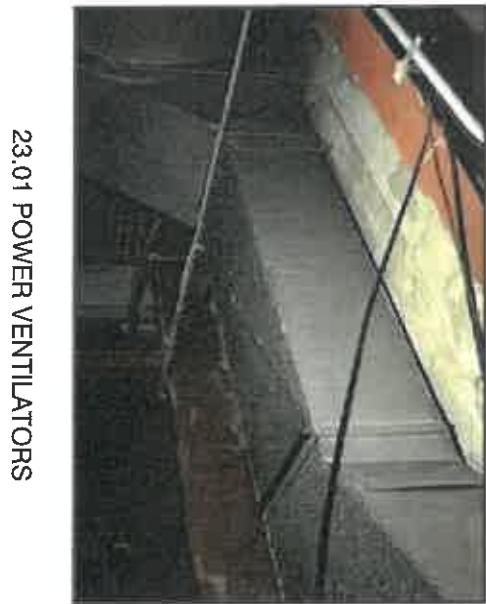
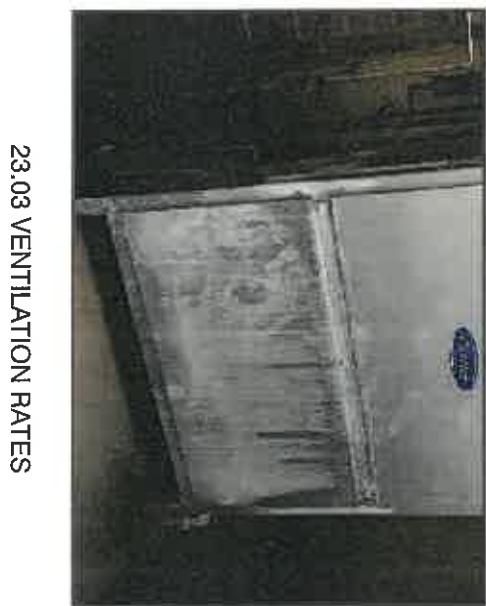
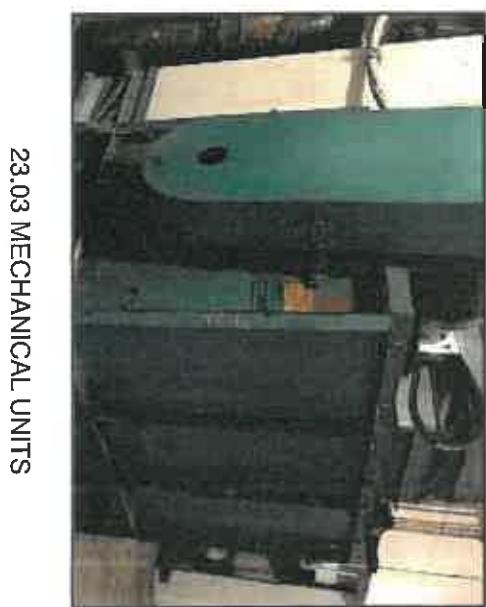
23.01 POWER VENTILATORS

In sufficient

Exhaust systems appear to not have proper protection from outside air infiltrating into the building. The exhaust fan located in the old Fire house basement that is causing the ductwork to fill with unconditioned air. The temperature difference between the unconditioned air and the conditioned interior space is causing condensate to form and leak into the conditioned space.

This equipment was manufactured around 2006 and the average life expectancy of this equipment is 15-20 years.

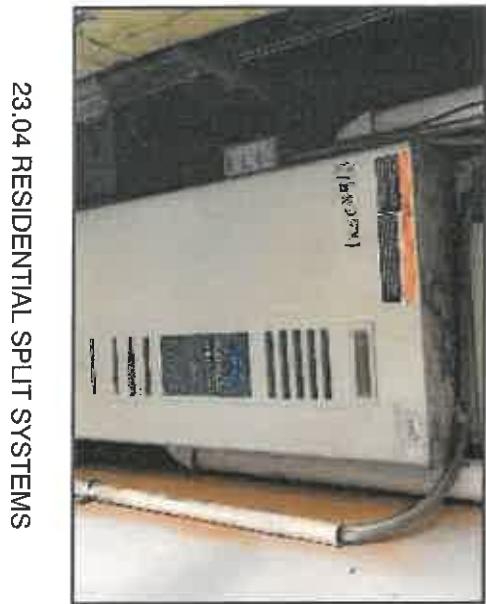
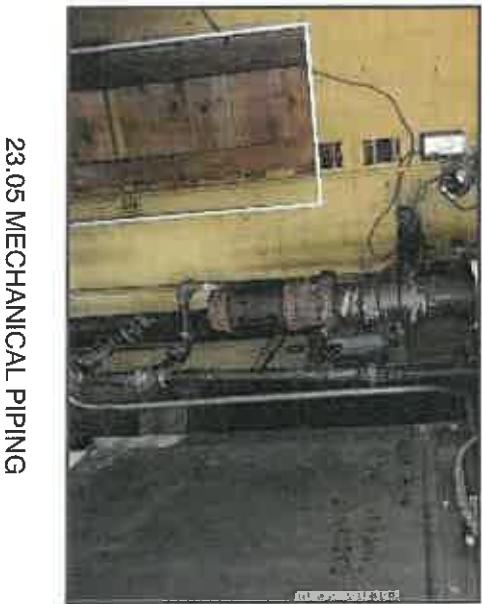
23.04 RESIDENTIAL SPLIT SYSTEMS

Unknown

The remainder of the building is served with residential split systems with DX cooling and natural Gas heating. These systems are not equipped to overcome any humidity issues with a space.

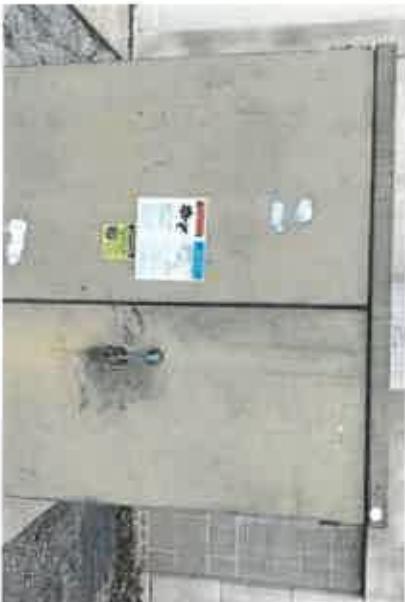
26.02 MAIN SWITCHBOARD

Inoperable

The main electrical switchboard is located in a basement hallway against the north exterior wall. It is a Federal Pacific QM/QB switchboard, 1600 amps, 120/208, 3-phase, 4-wire. The switchboard is likely adequately sized to service the building for any major renovation project, but it is not reusable for two reasons. Firstly, the switchboard has exceeded what is considered to be its useful life of 20-25 years, and it could experience catastrophic failure at any time. Secondly, replacement parts are no longer manufactured for this switchboard. Any renovation project would undoubtedly require a different configuration of switches. For these reasons, a new service entrance switchboard would be required as part of any upgrades to the facility. Additionally, we would recommend choosing a different location for the building's main distribution switchgear. The current location makes for difficult distribution of electrical feeders to different areas of the building.

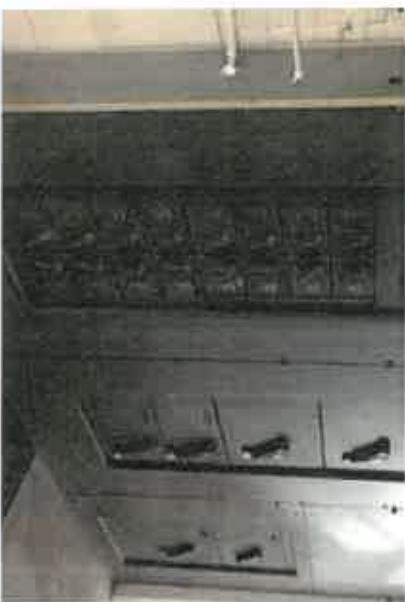
26.03 SUB PANELS

Inoperable

Existing panelboards in the facility are also outdated and have exceeded their useful life, with new parts no longer manufactured. Multiple manufacturers of panelboards were observed including Frank Adams and Federal Pacific. Certain subpanels were observed to be single-phase, 3-wire. Others were observed to be inadequately sized for the areas they serve.
