CITY HALL ANNEX - FACILITY ASSESSMENT REPORT

PREPARED FOR UNIVERSITY CITY

PREPARED BY TRIVERS

2019.08.07

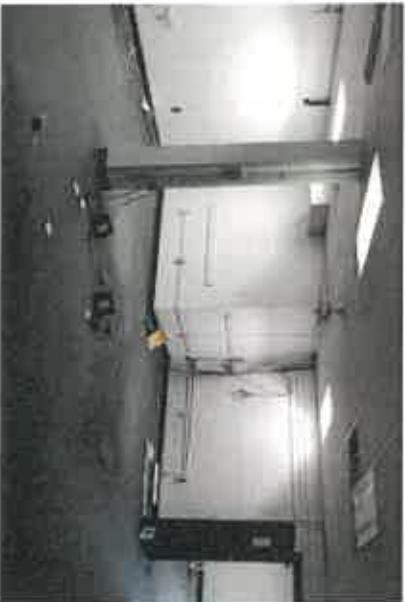
26.04 LIGHTING

In general, existing interior lighting consists of fluorescent lights with local light switches. The lighting is outdated, inefficient and prone to failure. The existing lighting would not be reused in any improvements to the facility.

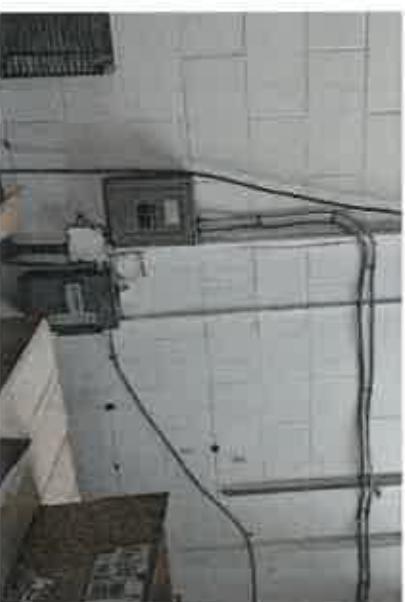
26.05 BRANCH POWER

No exposed wiring was observed. In general, exposed branch circuits were installed in conduit or in MC cable. From casual field investigation, it was unclear whether the existing branch circuits are properly grounded.

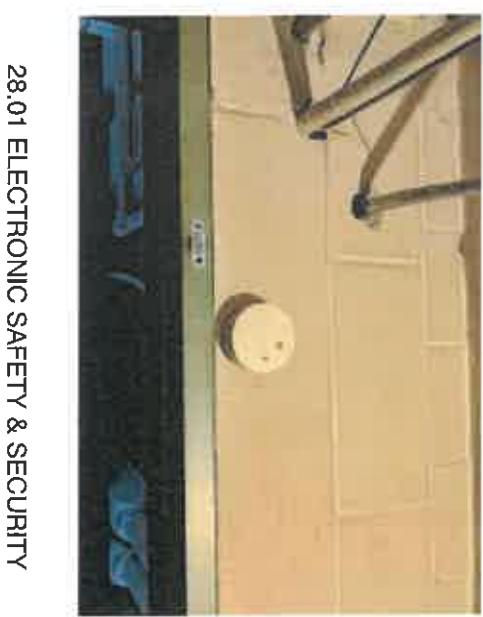
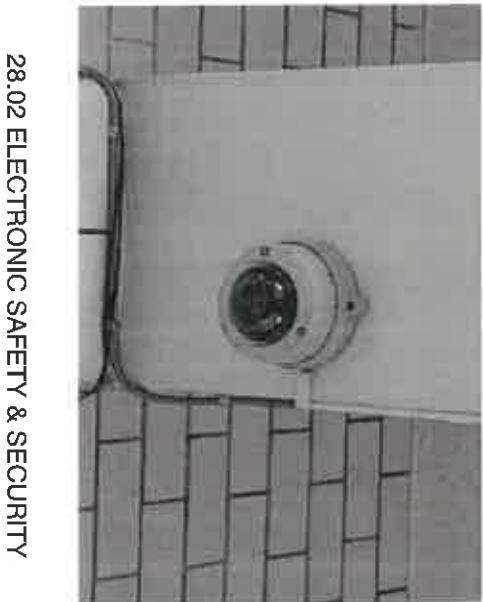
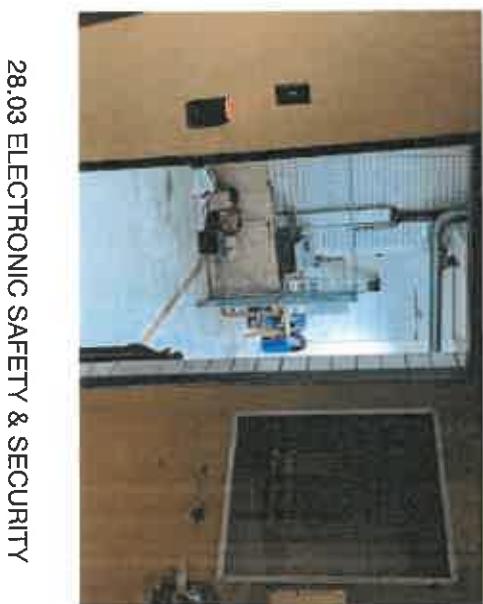
28.01 ELECTRONIC SAFETY & SECURITY

Fire Alarms

A fire alarm system was not observed. Battery operated smoke detectors were present in certain areas. Any improvements to the facility would require the installation of a new fire alarm system. Ideally, the fire alarm system would be connected and/or integrated with the fire alarm systems of the connected structures and the University Police building to the north.

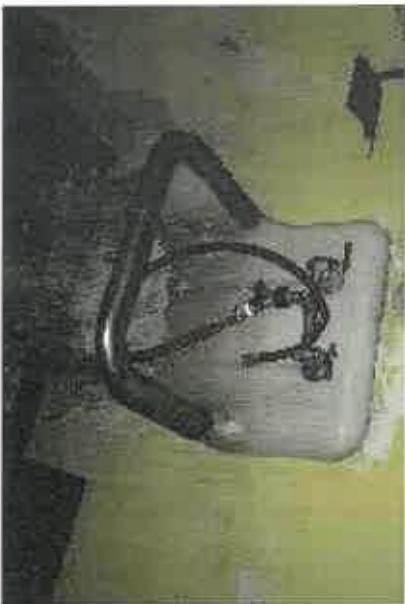
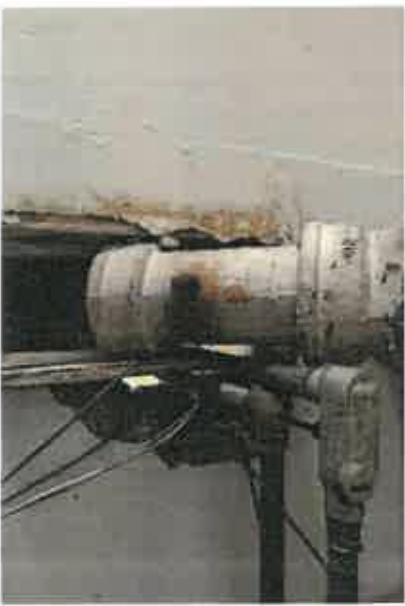
22.02 PLUMBING PIPING

The existing piping appears to be a mixture of never PVC piping and older, possibly original to the building, cast-iron piping for the sanitary and storm systems. The domestic water piping appears to be copper of varying years.

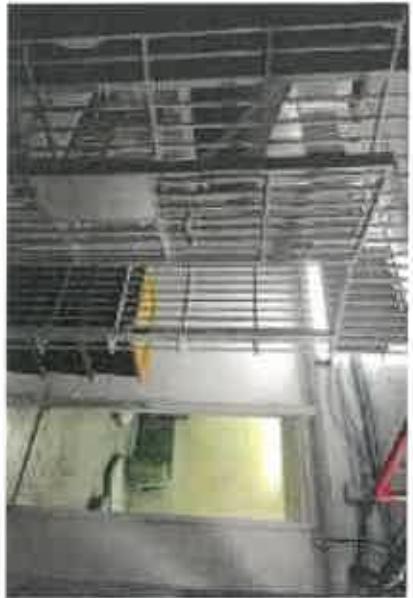
FIRE PROTECTION Sprinklers

It appears that only the main three cells in the basement are covered by wet sprinklers.
